Our rotor modeling service defines a new balancing standard for a repaired turbine rotor

by Ron Bosmans

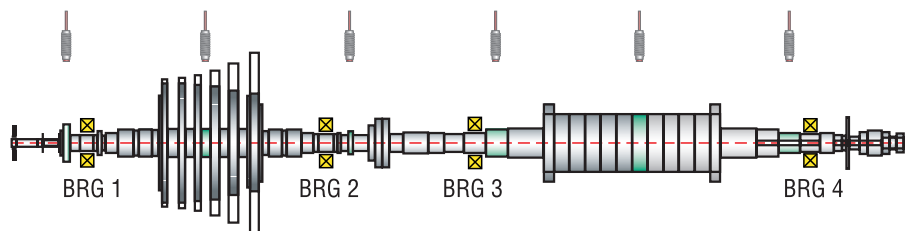
Figure 1. Computer model of steam turbine generator rotor.

Bently Nevada's Machinery Management Services organization was contacted to help explain the observed behavior of the machine. Drawings were obtained, a rotor model was created (Figure 1), and the computer-generated forced response provided the modal information to define the midspan deflection of the turbine rotor. Discussions were also held on the nature of the rotor repairs after the initial rub event. The damaged sections of the rotor required re-machining to smaller shaft diameters. The direct stiffness property of the rotor had been reduced, which allowed the rotor to have higher midspan deflections in response to residual unbalance forces.

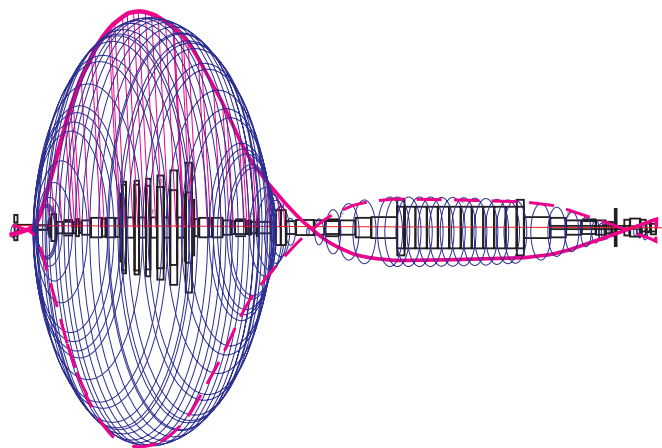
Figure 2. Mode shape of modified rotor at balance resonance frequency.

The rotor mode shape at the balance resonance frequency is shown in Figure 2. This analysis offered clear evidence why the internal rub of the rotor had occurred. It was also clear that the allowable residual unbalance of the rotor currently under repair must be considerably more stringent.

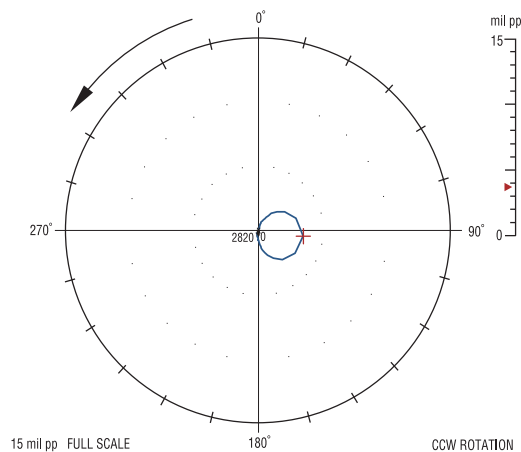
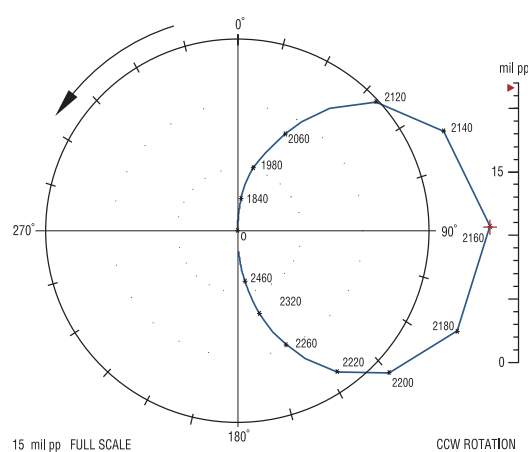
Figure 3. Polar plots showing the calculated response of modified turbine to original residual unbalance standard at Bearing #1 and turbine midspan.

Balancing records from the high-speed balancing facility were obtained. The repaired and rebuilt rotor was balanced to a residual unbalance state of 24.1 g·m (33.5 in·oz). This value was used in the computer program for the forced response run.

Figure 3 shows the polar plots of the calculated rotor response at Bearing #1 and turbine midspan location. When the rotor speed was at the first balance resonance frequency, vibration at Bearing #1 was calculated to be 97.0 μm (3.82 mil) pp. The midspan vibration was calculated to be 551 μm (21.7 mil) pp.

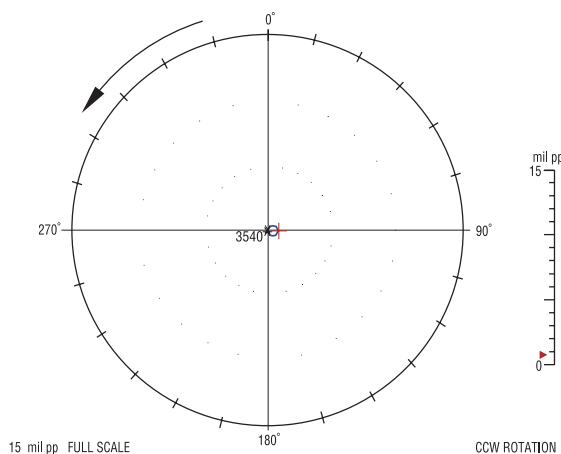
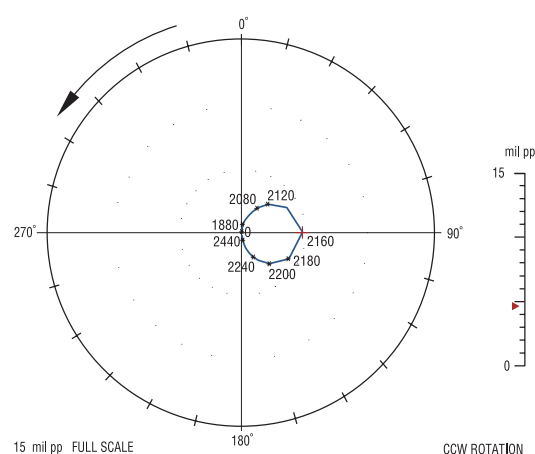
Figure 4. Polar plots showing the calculated residual unbalance response to new unbalance standard.

allowable residual unbalance to ensure a successful re-commissioning of the turbine. The new standard was determined to be a maximum of 8.78 g·m (12.2 in·oz), about one-third of the original. The polar plots of the calculated response with this unbalance are shown in Figure 4.

This information was forwarded to the high-speed balancing facility. The turbine rotor was successfully balanced to this standard and returned to the job site for re-commissioning. The startup of the unit was successful and uneventful.
